Report on Dorji Goenpa Lhakhang

Introduction

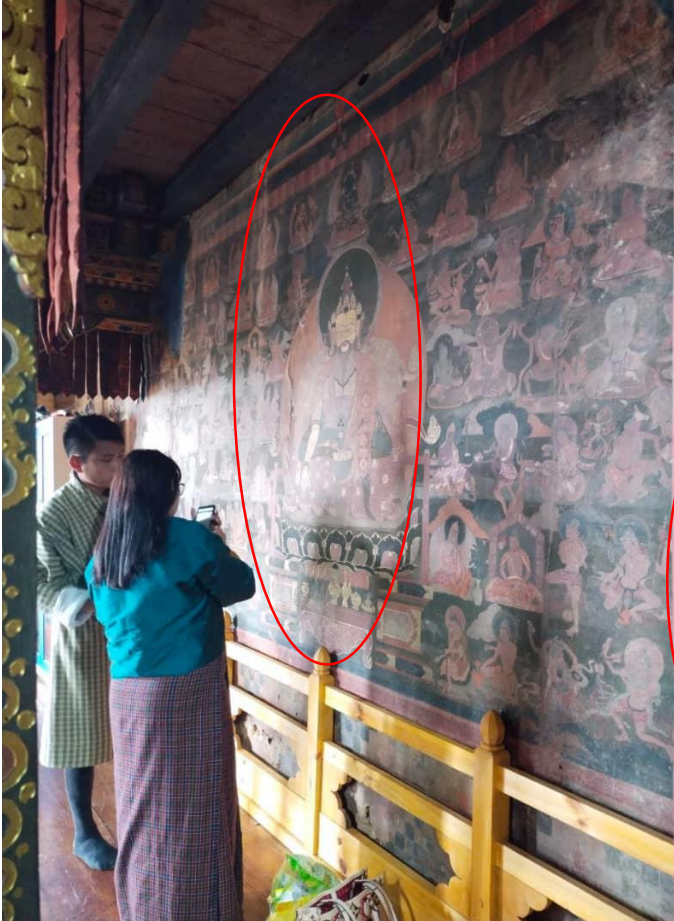
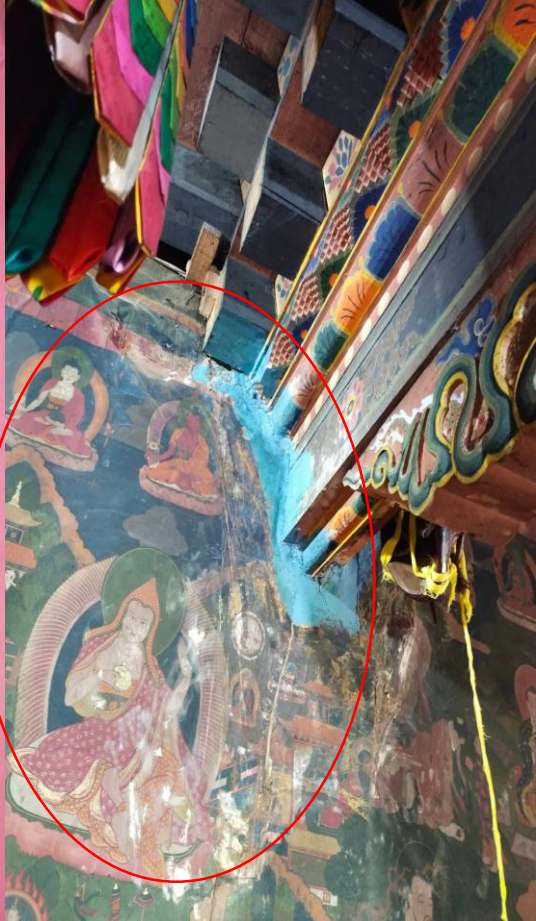
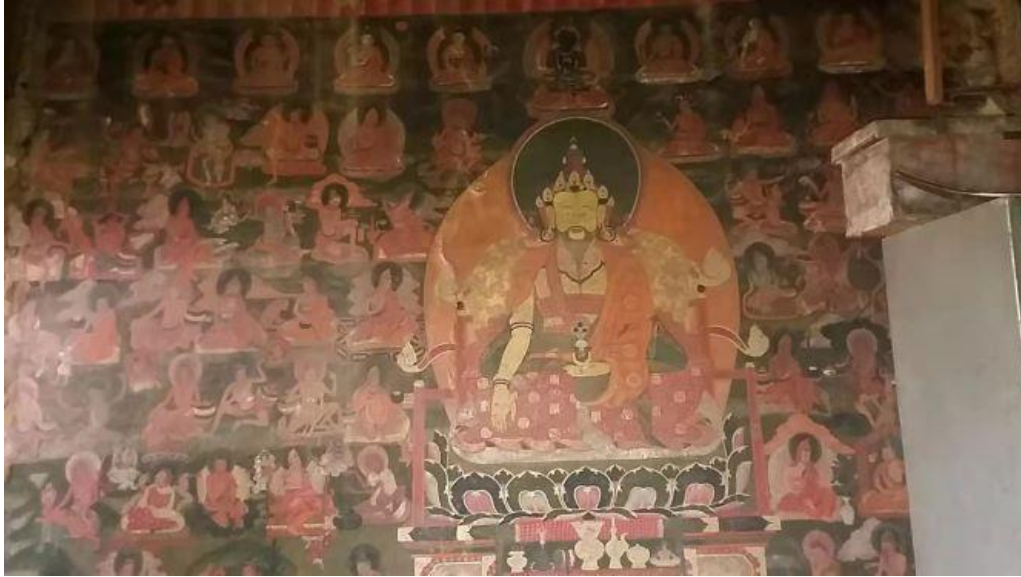
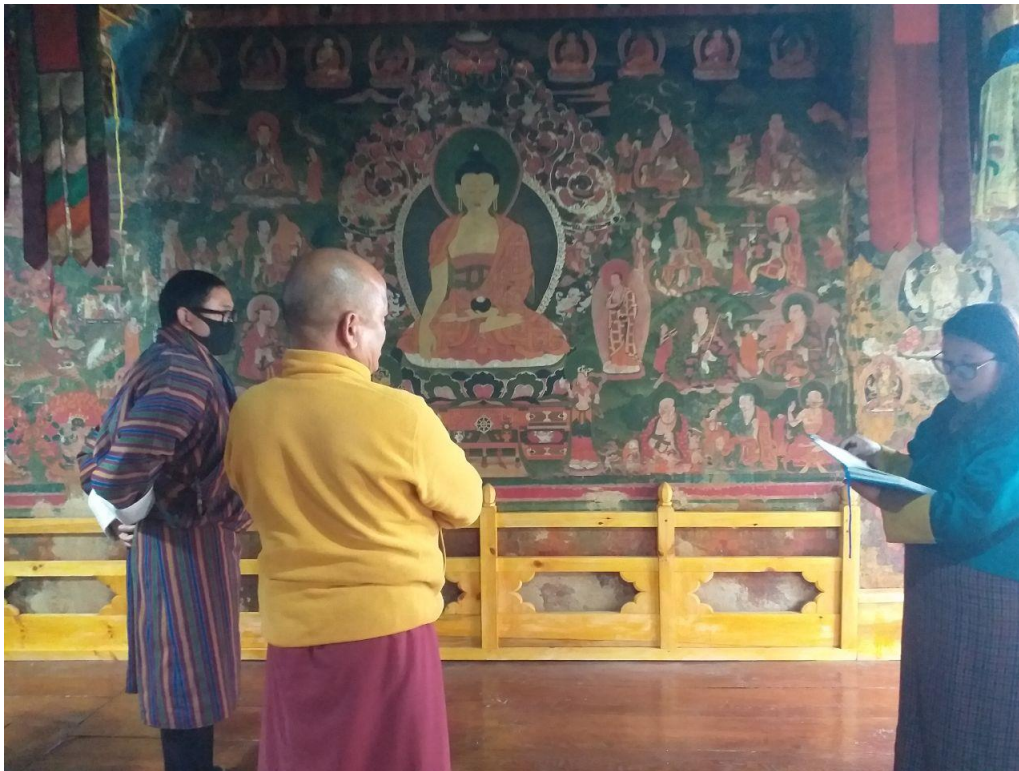
Condition of wall painting

The soil deposition from the roof is visible in the wall painting. Some of the paintings have solid depositions of soil that have hardened over time. The paintings are discolored, and some of the images are incomplete. Insect has attacked and ripped holes in the painting canvas.

- Superficial cleaning
- Cleaning of soils from painting surface
- Removing of solid soil
- Using insecticide for insect attack areas.

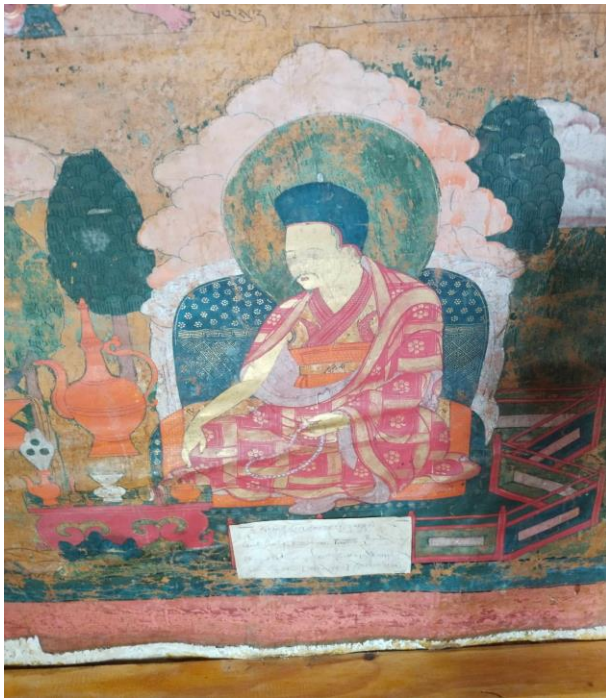
Label pasted using staple pin- rusting of metal will impact the wall painting
